AFWAL-TR-80-2112

FIRE RESISTANT AIRCRAFT HYDRAULIC SYSTEM

BOEING MILITARY AIRPLANE COMPANY
ADVANCED AIRPLANE BRANCH
P.O. BOX 3707
SEATTLE, WASHINGTON 98124

FINAL REPORT FOR PERIOD MAY 1976 - MAY 1980

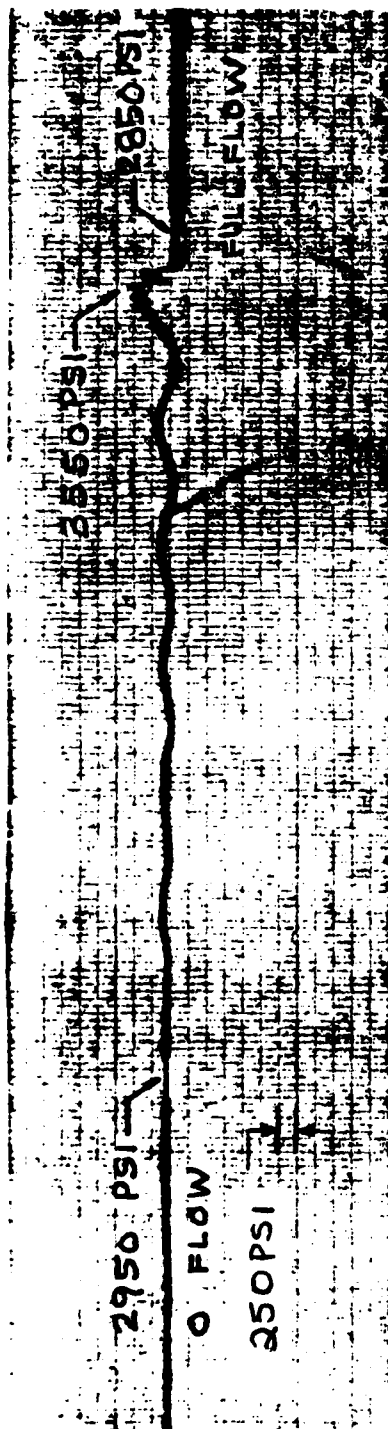
Figure 56a. Pressure transient due to a sudden valve closure while pumping A0-8 fluid into a 250-cu.in. system

The oscillograph traces of discharge pressure vs time taken at the three speed conditions, for both a sudden valve closing and a sudden valve opening, with and without the added 200 cubic inch compliance volume are shown in Figures 58 through 63. The measured response times, with and without the added compliance volume, are tabulated in Tables 23 and 24 respectively. The response times measured during the qualification test of the PV3-075-1 pump, operating with fluid per MIL-H-5606 in a system with very little compliance volume (8-10 cu. in.), are tabulated in Figure D-8 in Appendix D.

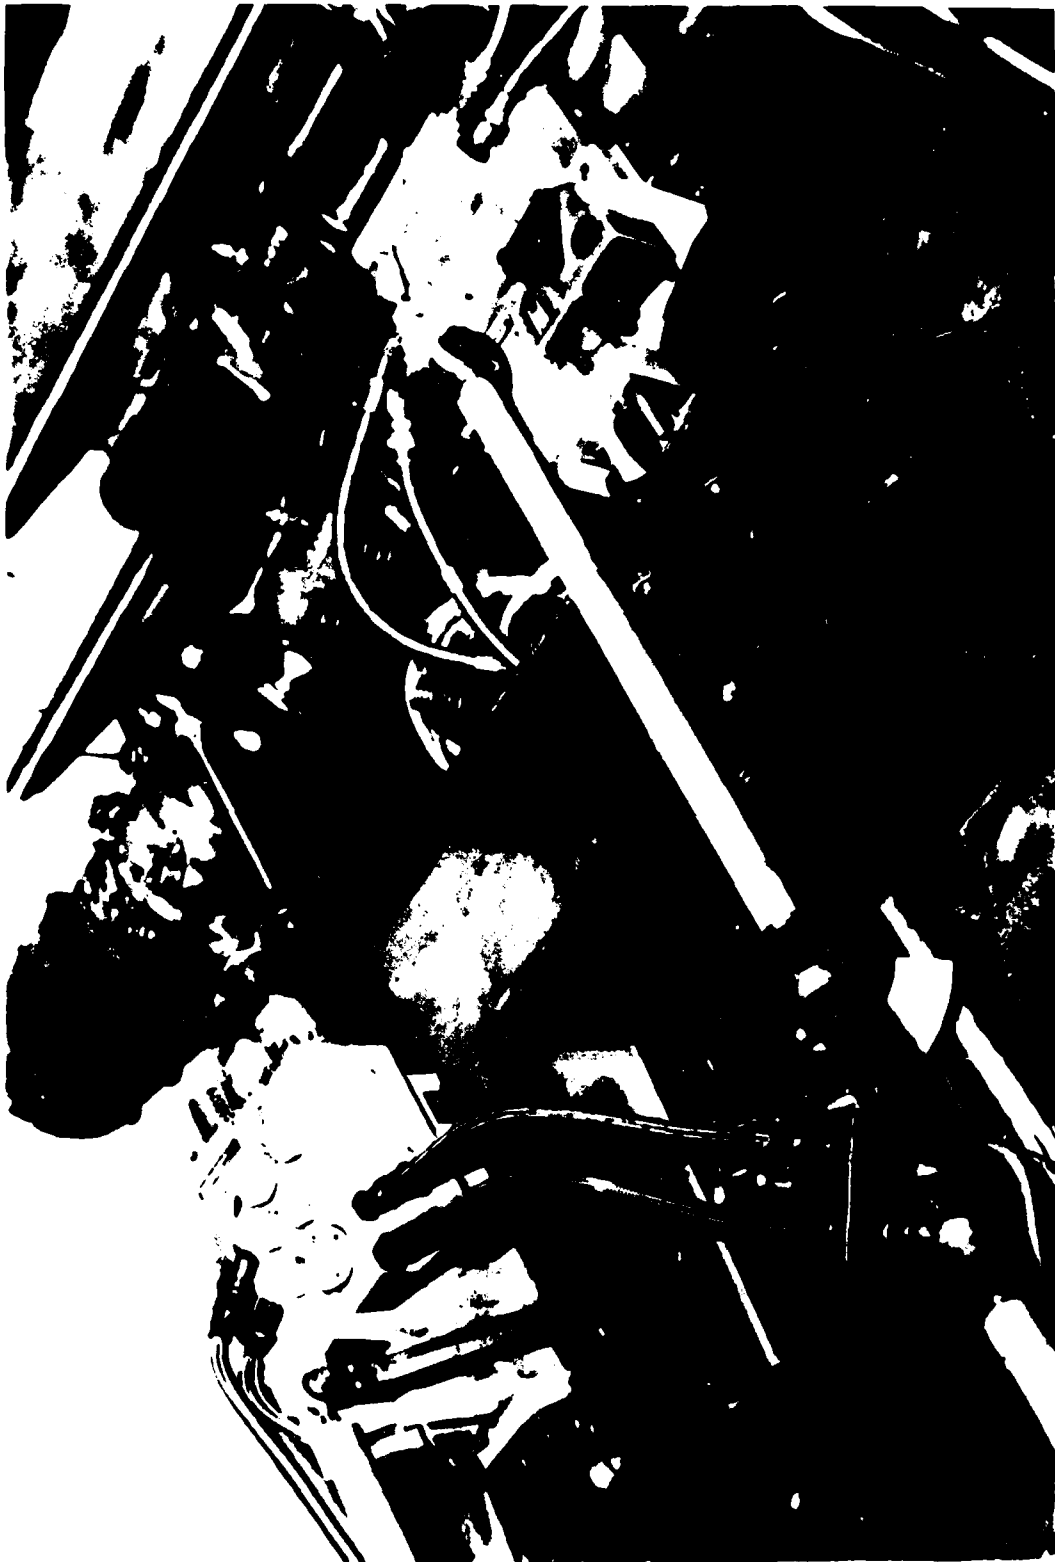
Figure 95. Servoactuator loading system
